SIO Shipyard Representative Bi-Weekly Progress Report		
<b>Project: AGOR 28</b>	<b>Contract No.: N00014-12-C-0305</b>	<b>Shipyard: Dakota Creek Industries</b>
<b>Prepared by:</b> Paul D. Bueren Scripps Institution of Oceanography (SIO) 297 Rosecrans St. San Diego, CA 98106	<b>Date:</b> 8 April 2016	<b>Program Officer:</b> Robert (Tim) Schnoor Office of Naval Research 875 Randolph St ONR 321 Arlington, VA 22203-1995
<b>Distribution Statement A:</b> Approved for public release; distribution unlimited.		<b>Report No. A002.097</b>

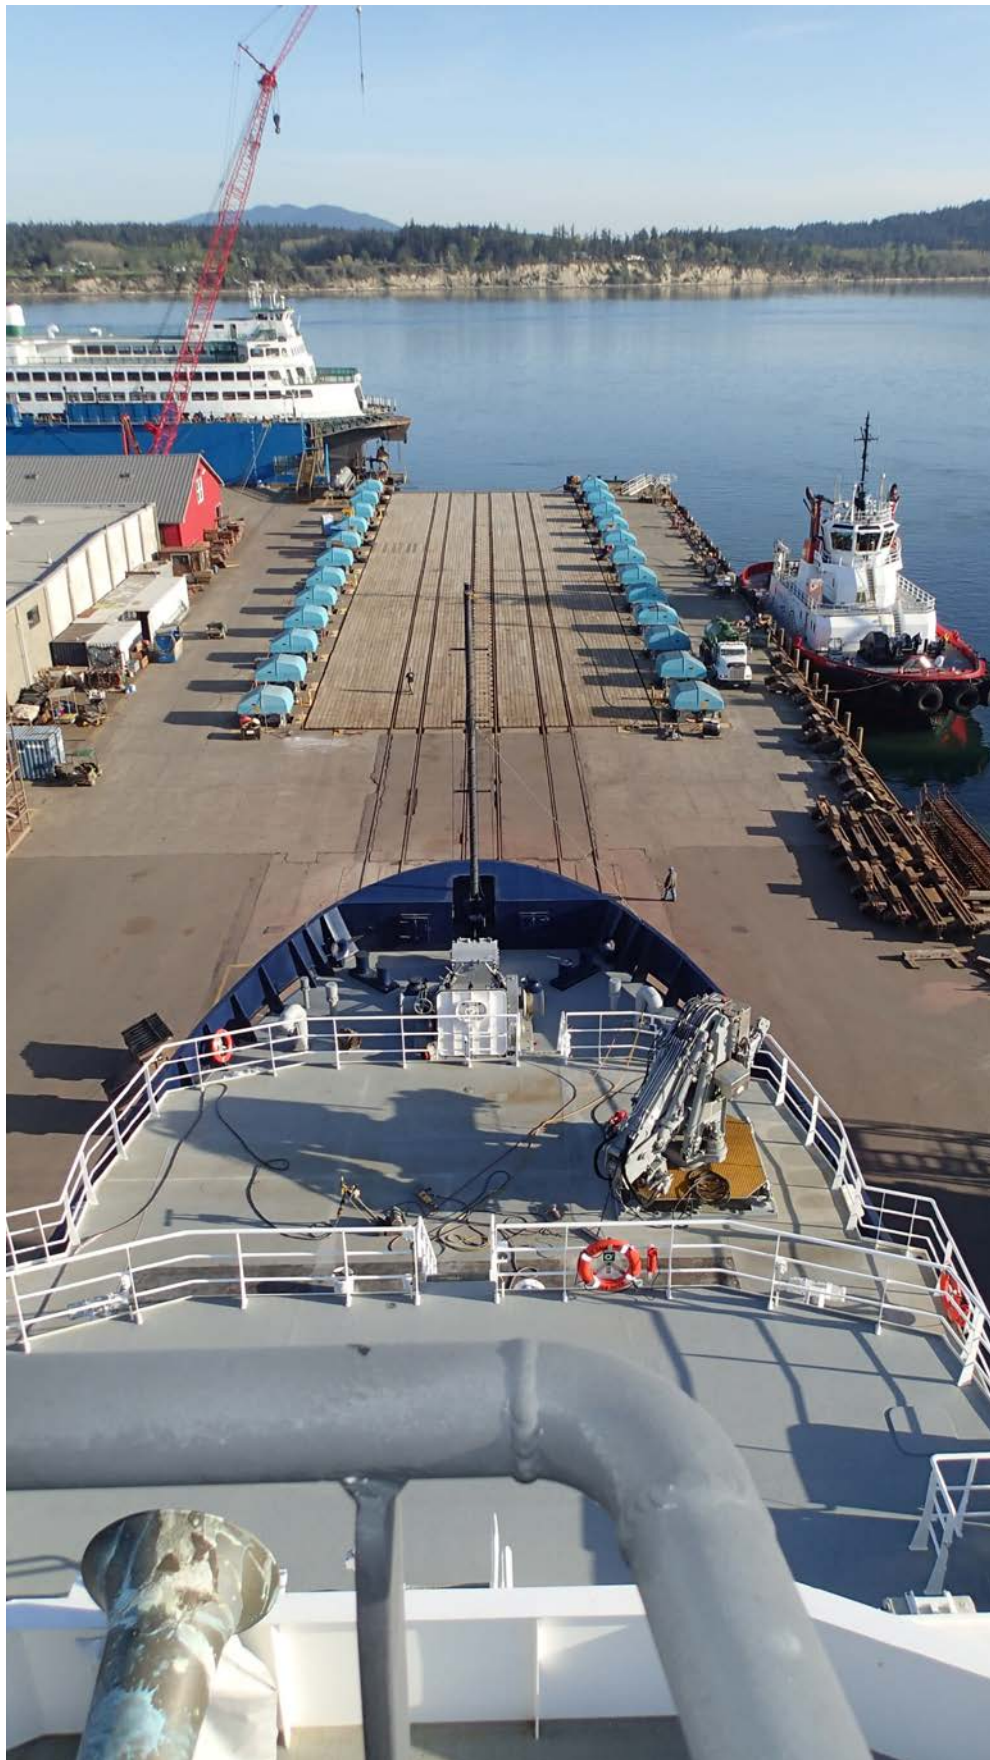
- Topside Paint – Painters are making hay while the sun shines. Where necessary, they are going down to bare metal prior to coating.
